AIRCRAFT ACCIDENT REPORT

UNCONTAINED ENGINE FAILURE
DELTA AIR LINES FLIGHT 1288
MCDONNELL DOUGLAS MD-88, N927DA
PENSACOLA, FLORIDA
JULY 6, 1996

**Adopted: January 13, 1998
Notation 6725C**

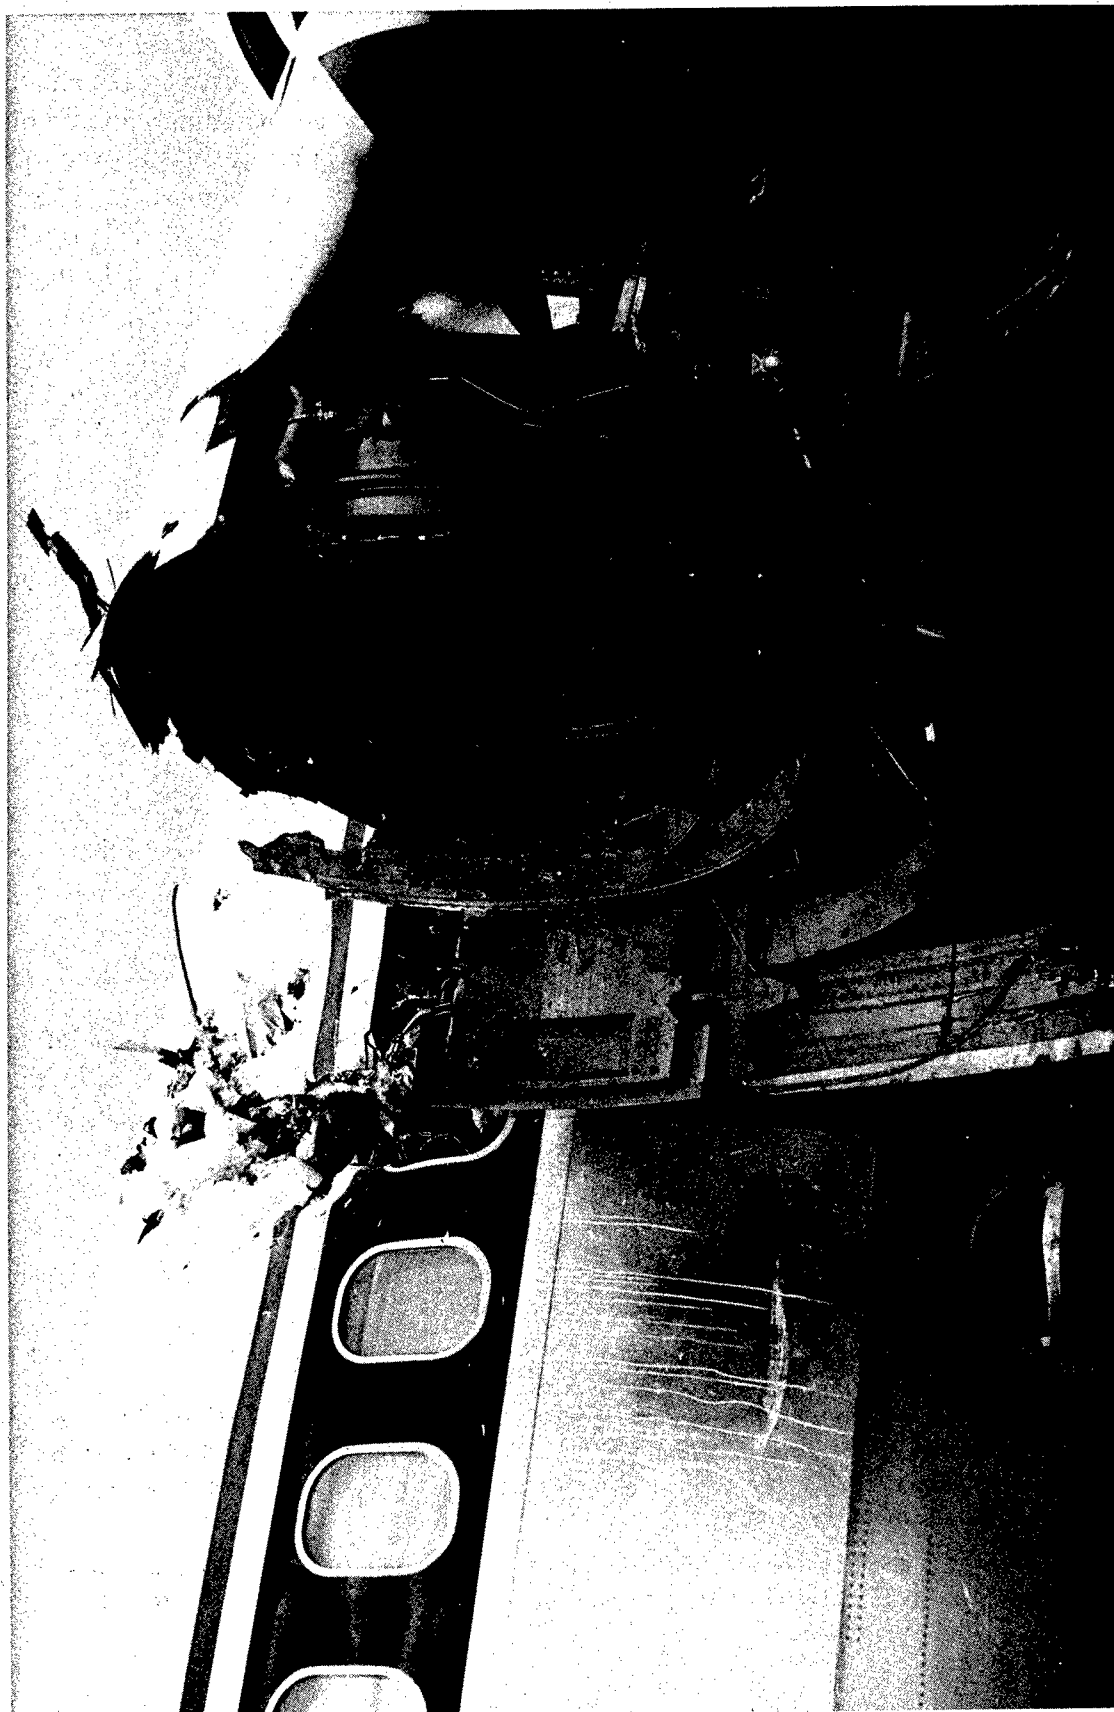
The aft left fuselage and interior of the airplane in the vicinity of the No. 1 engine were substantially damaged by debris from the engine (see figure 1). A total of 16 holes, punctures, or tears were documented on the left fuselage skin. Several large holes and tears were

Figure 1.—Damaged area of airplane near No. 1 engine.

The cabin interior was substantially damaged near seat row 37, next to the left engine. Debris from the left engine's fan hub and fan blades had penetrated the left cabin wall and overhead bin vertically from the lower left passenger window through the overhead bin and ceiling panel. Engine fan components had also pierced the side and ceiling of the right cabin wall.

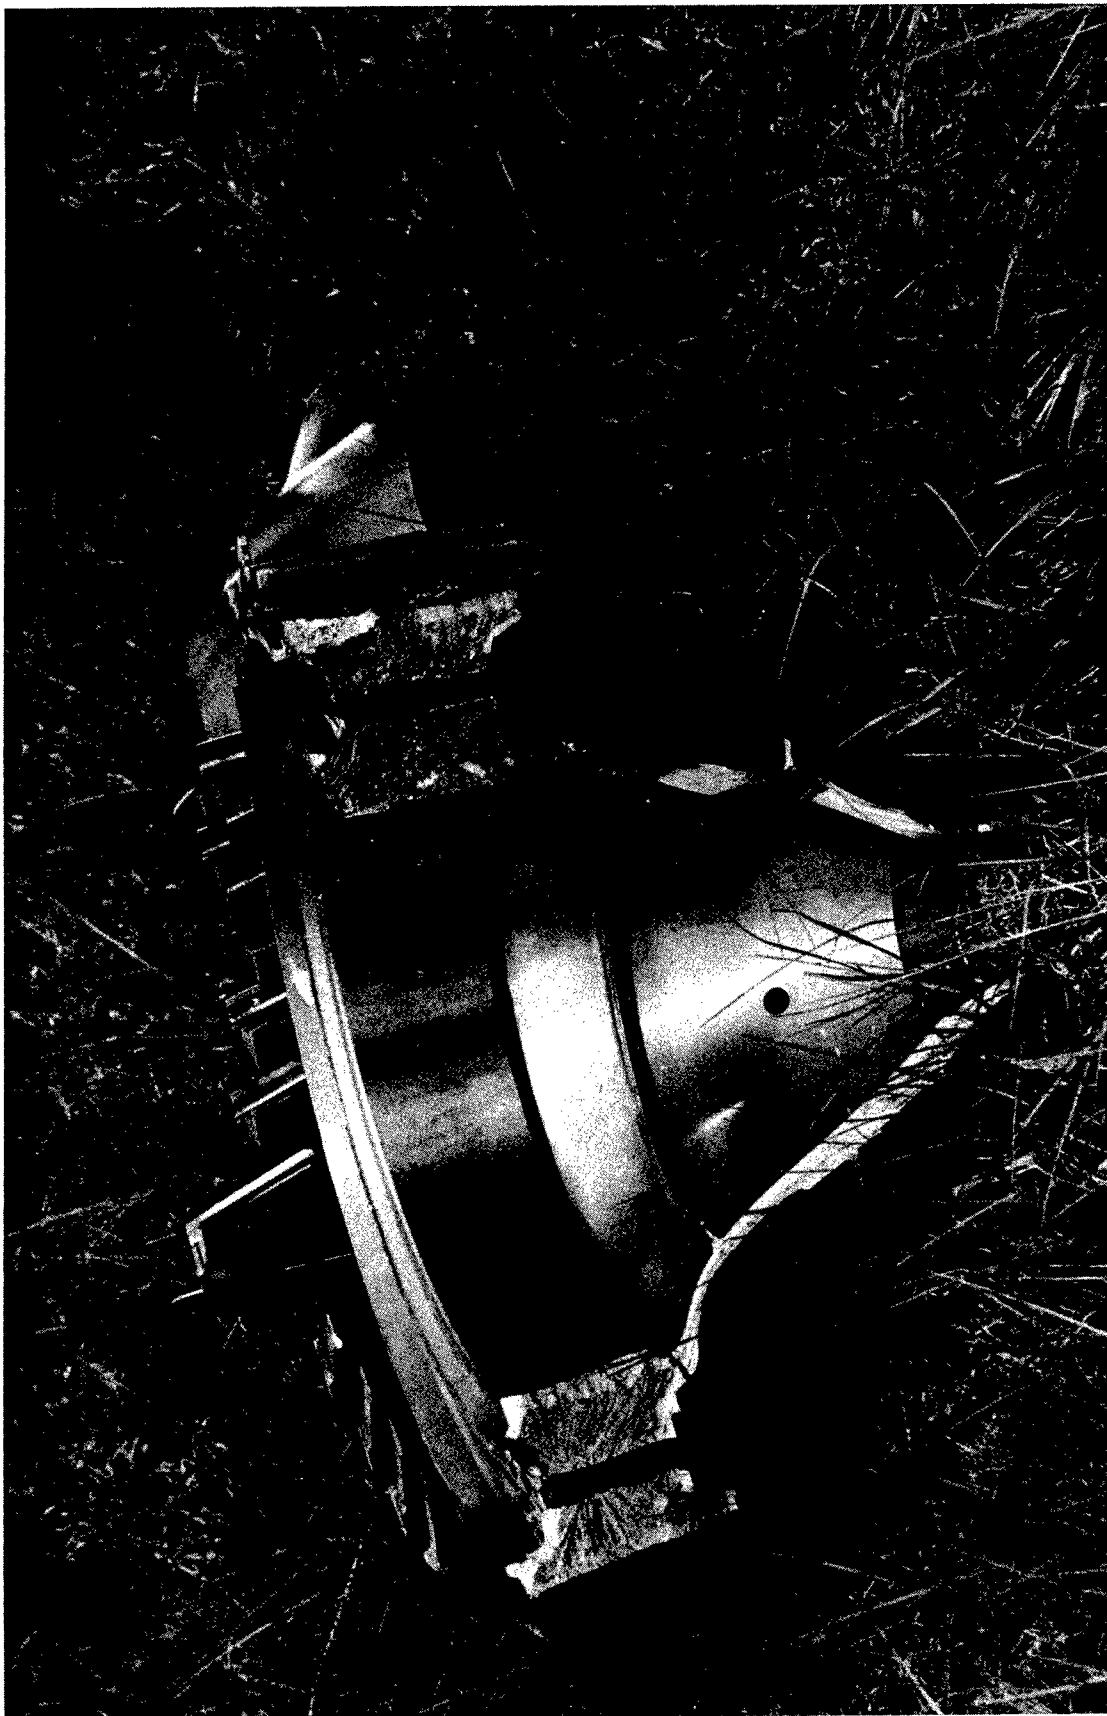
The fan hub fractured through a tierod hole and blade slot. There were two fan blade roots still in place on the small rim segment and 13 blade roots on the larger rim segment. Three of the 13 blades were full length and bent counterclockwise as viewed from aft looking

Figure 6.—Two-thirds of hub rim and adjoining conical section.

forward (ALF).³⁰ A smaller fracture surface was found at the forward section of the conical hub oriented at right angles to the hub axis and extending 360° around the part circumference. The hub rim's fracture surfaces were examined at the accident site by a Safety Board metallurgist and were found to have evidence of fatigue cracking.

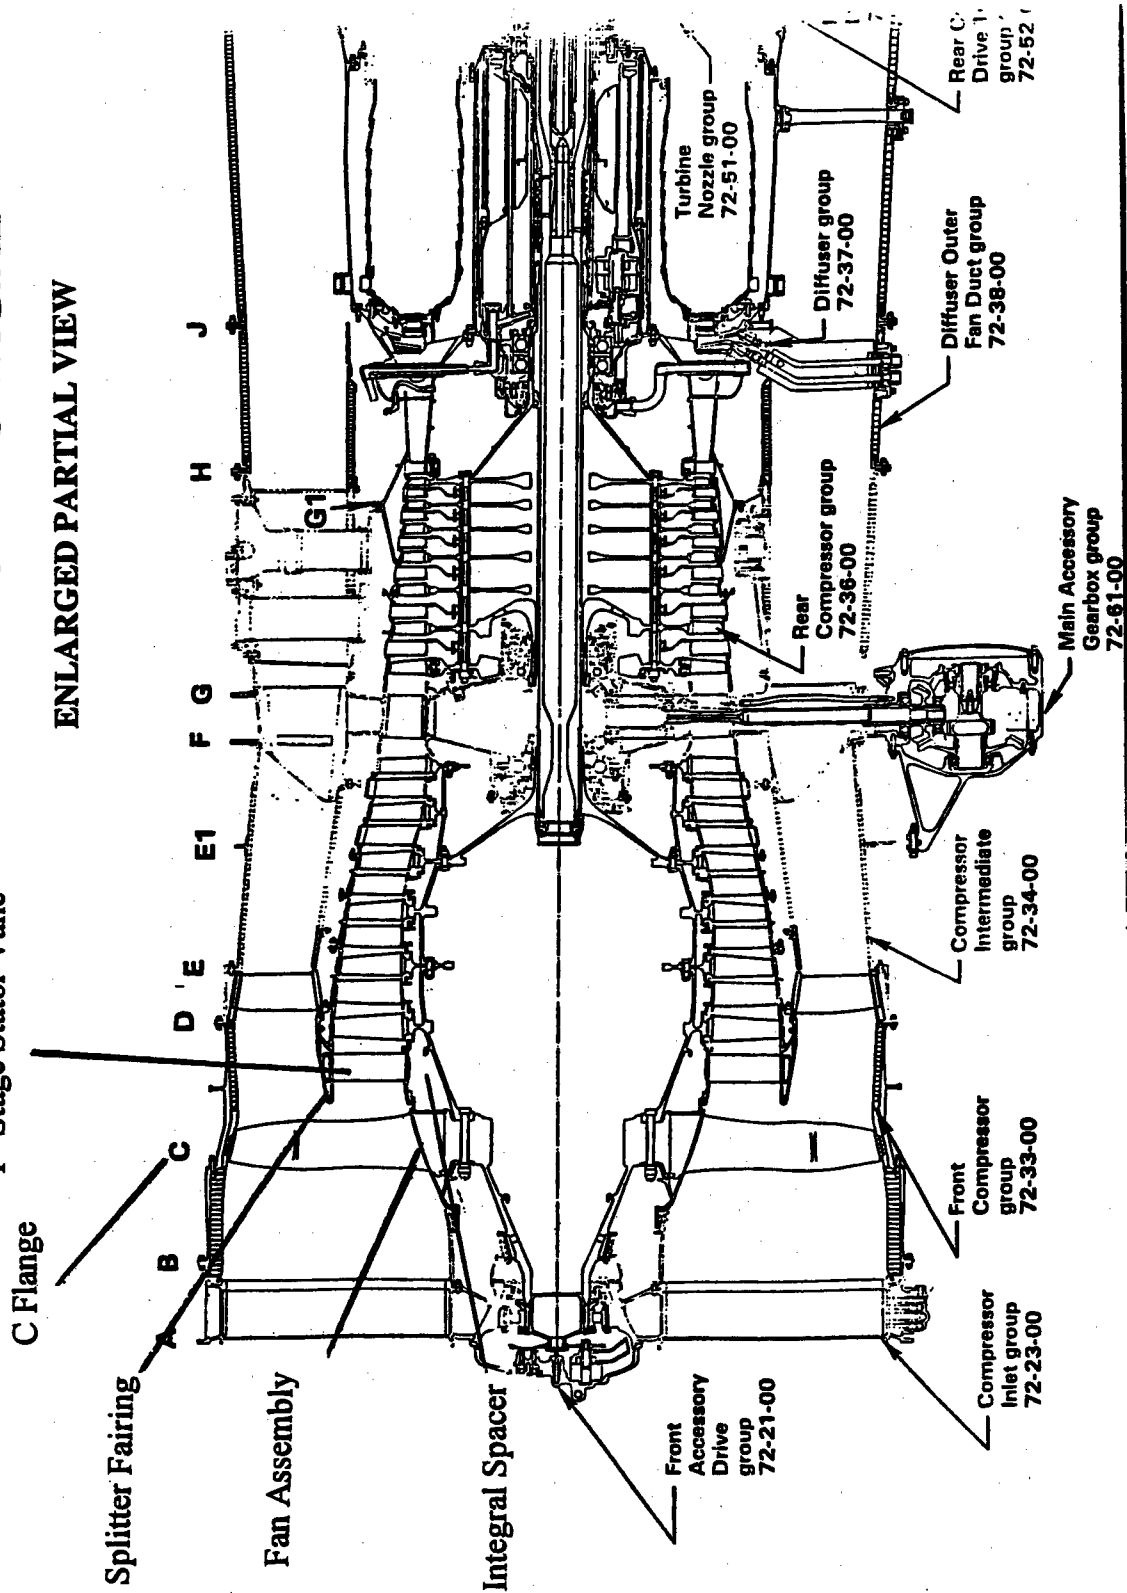
The outer engine case separated at the C flange (see figure 7).³¹ Forward of the C flange, the case remained attached to the cowl. The case was torn and fragmented in two areas (centered at the 1 o'clock and 7 o'clock positions) between the C and D flanges. The 1 o'clock position was missing a segment from the 12:30 to 2 o'clock positions. The case was intact but had been torn loose from the D flange between the 2 o'clock and 3 o'clock positions. A 14-inch circumferential part of the fan rear case was found on the runway 61 feet to the right of the centerline and 441 feet from the runway threshold. Acoustic honeycomb in the fan case area was ripped, torn, or missing in many places. The splitter fairing³² (see figure 7) was missing from the 1 o'clock to the 7 o'clock position. A torn piece of the splitter remained attached at the 5 o'clock position. Twelve first-stage stator vanes³³ were present on the remaining splitter fairing. The inner diameter ends of the vanes were separated from the inner shroud and bent in the direction of rotation.

Figure 7.—Enlarged, partial view of outer engine case of JT8D-200 series engine.

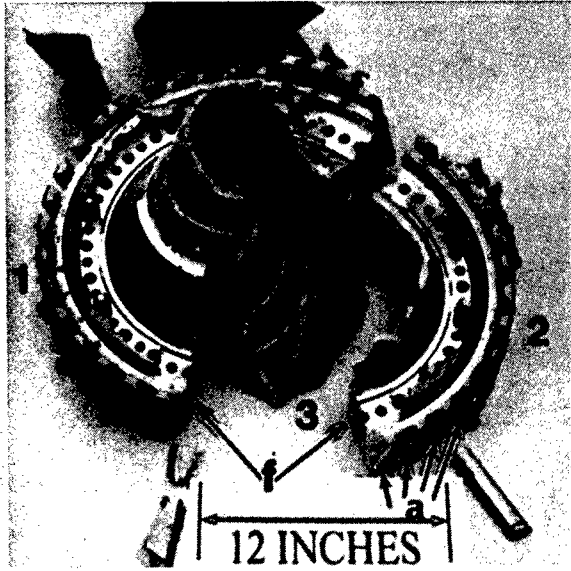
A scanning electron microscope (SEM) examination of the fracture face in the origin areas showed evidence of overstress to a depth of about 0.002 inch adjacent to the hole wall. The overstress fracture region was followed by an area about 0.006 inch deep that contained fracture features consistent with a fast-propagating fatigue crack. From a depth of 0.006 inch to the end of the fatigue region, striations were found consistent with a slower propagating fatigue crack.

Figure 9a.—Fractured fan hub.

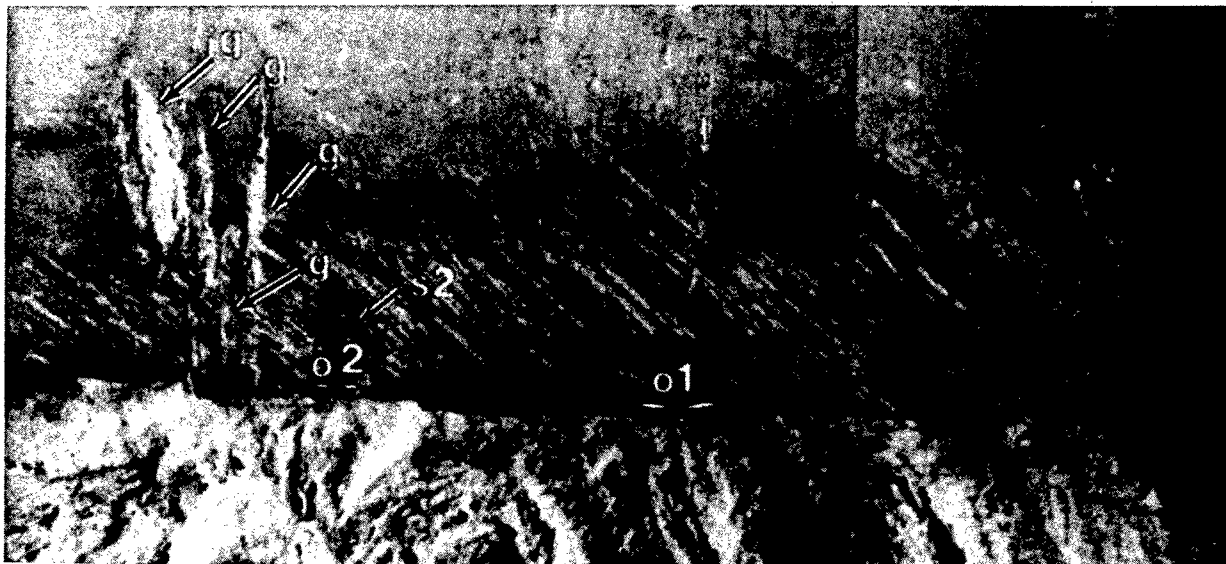
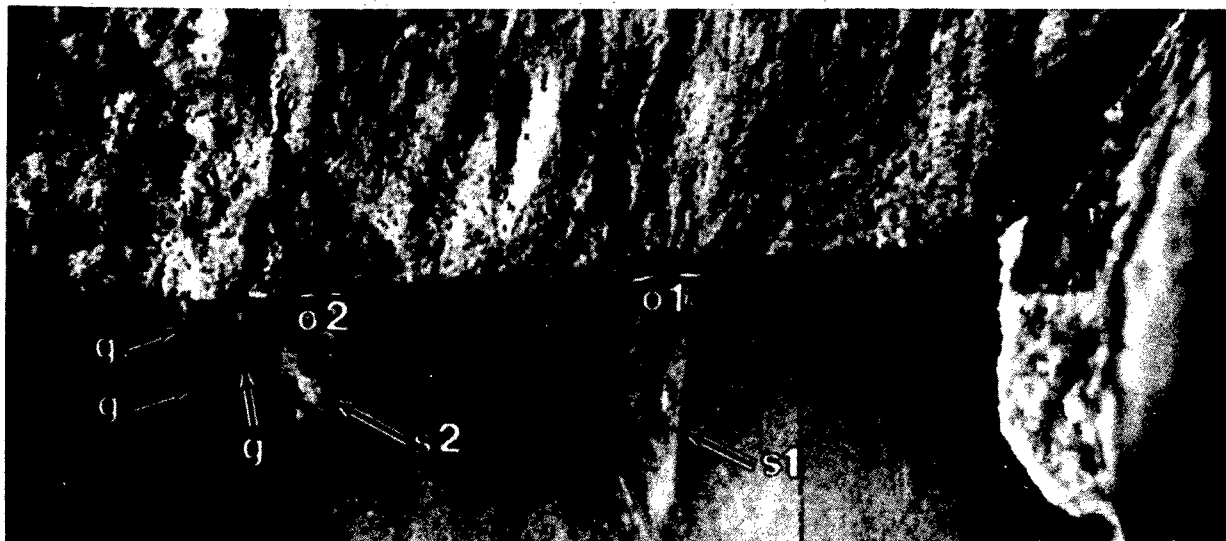
Figure 9c.—Magnified view of fatigue fracture features.
